Do you ever get Black Spec contamination on clear parts?

(Submitted by Richard Graf, The Nypro Oregon Team. June, 2001)

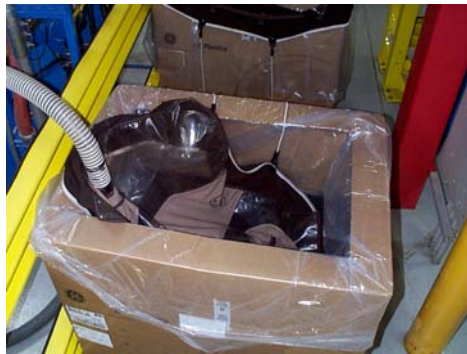
One of the first things we noticed was that more often than not the covers on our Gaylords were being sucked into the Gaylord from the vacuum tube.

So the material handlers had to constantly keep pulling them back up on top of the Gaylords. They also had to reach into the Gaylords to move material down toward the vacuum tube so it could suck the material up into the hopper. Now we run a lot of black materials in our plant, many with glass or carbon fillers. Dust from regrind and general handling does get into the air. When a Gaylord cover is in place it prevents that dust from getting into the material, but every time it falls into the Gaylord or the material handler removes it to move the material toward the end of the vacuum tube that dust falls into the clear material. It doesn't matter how careful you are, it is going to happen.

The first thing we did was to add plastic tarp holders to two sides of each Gaylord cover. We then bought fairly light duty bungee cord by the roll with plastic clips that fit on the ends. We can now slide the bungees through the pallet and clip the cords onto the covers, thus preventing the covers from being sucked into the Gaylord. (Make sure you don't make them too tight or you may create a hazard when releasing one side)

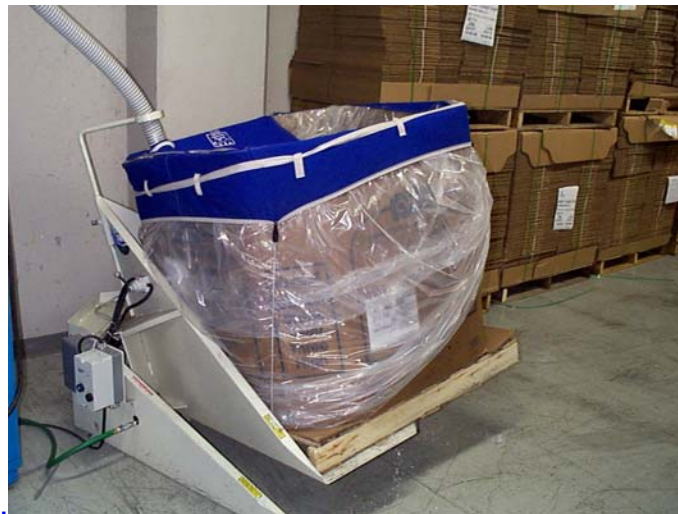
Next we reran our material vacuum lines to allow us to run multiple machines from a single Gaylord. This reduced the handling required for each machine and we added a Gaylord tipper with a vibrator so that the Gaylord would be nearly empty before ever having to be opened

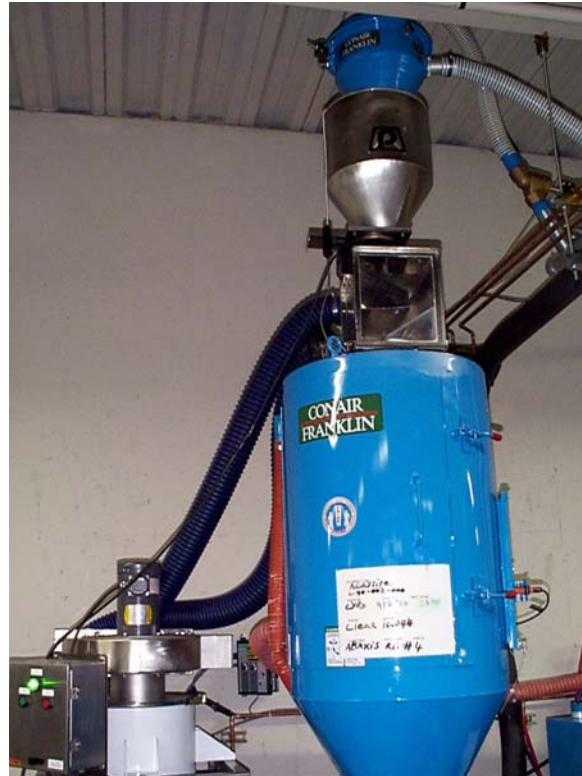
This device not only vacuums off fines, but it also uses anti-static disruption to help release the fines from the pellets due to static electricity. We mounted it on top of the drying hopper. It instantly stopped the burning of the fines in the styrene and we were able to stop the black spec problems that occurred in almost every shot. But an interesting thing happened as we began to check the fines that were being pulled off; we saw that there were still foreign specs in the fines.

P-5 Mini-DeDuster™ Assembly Mounted on dryer. Includes inlet hopper and inlet flow control slide

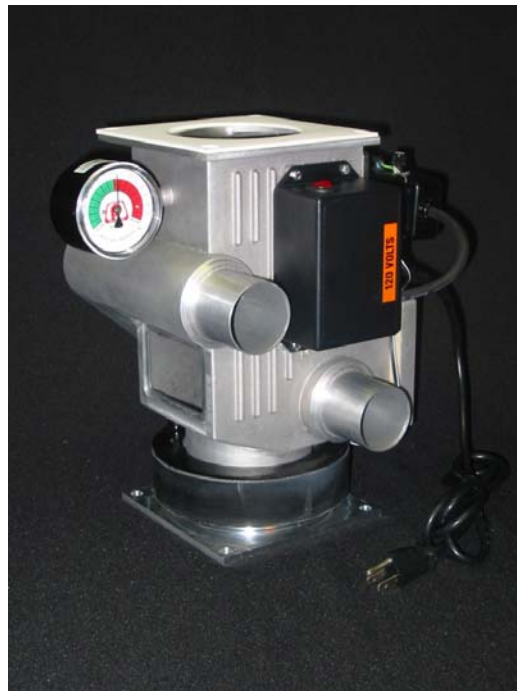
P-1 Mini-DeDuster Assembly

What we learned was that if they did get into our clear material, we could still keep them from getting into our parts with the use of the DeDuster™. So, we added another P-1 mini-DeDuster™, (100#/hr capacity) to the molders for the acrylic jobs.
